Manhole Inspection Summary

Manhole # **S29G__027MH**

Insp Date: **10/2/08 8:28 AM**

Location Address: **100 Violet Hill White Way**

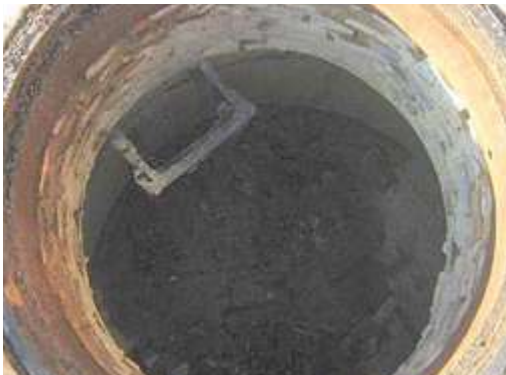
Frame View

Condition: ☒ Sound ☐ Cracked ☐ Leaks

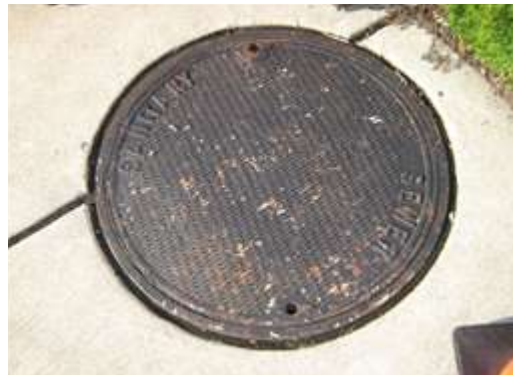
cover pic

Condition: **Sound**

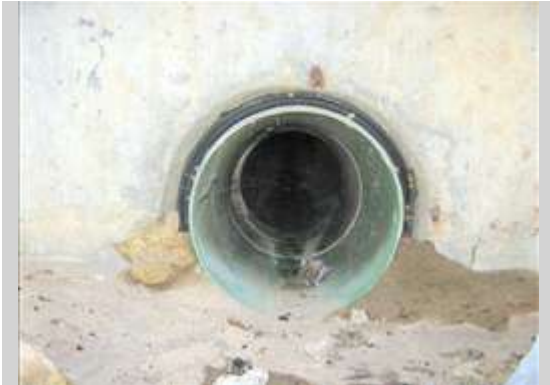
12 O'Clock Outflow

8 in. Circular Gravity Sewer
Pipe Out @ 12 O'Clock

Deposits: ☒ None ☐ Mud ☐ Sludge ☐ Debris ☐ Grease

Infiltration: **None** Pipe Seal Cond: **Sound**
